ARKANSAS  
Department of Environmental Quality

SUBJECT: Diaz Intermediates Corporation  
301 Wyanoke Drive  
West Memphis, Arkansas 72301

## MEMORANDUM

SUBJECT: Diaz Intermediates Corporation  
ARR000005843  
AFIN 18-00401

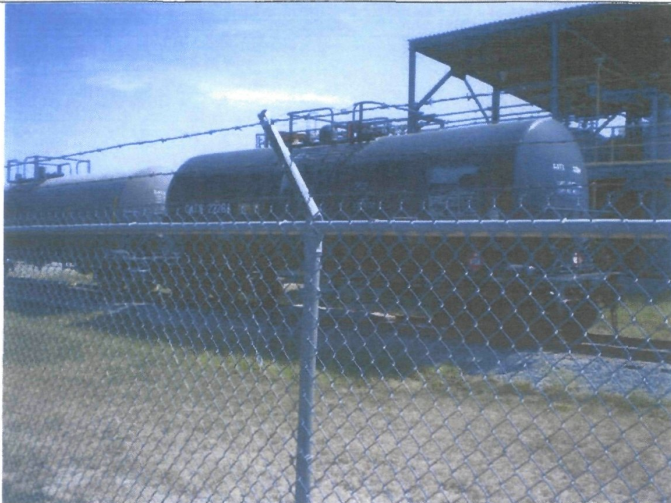
<b>Location:</b>	Diaz Intermediates Corp., 301 Wyanoke Rd., West Memphis, AR 72301						
<b>Photographer:</b>	Les Branscum, ADEQ				<b>Witness:</b>	Penny Wilson, ADEQ	
<b>Photo #</b>	1	<b>Of</b>	10		<b>Date:</b>	22 AUG 07	<b>Time:</b> 1105
<b>Description:</b>	View of Diaz rail spur from outside facility fence, west side. Rail car is placarded Flammable Liquid, UN 1993.

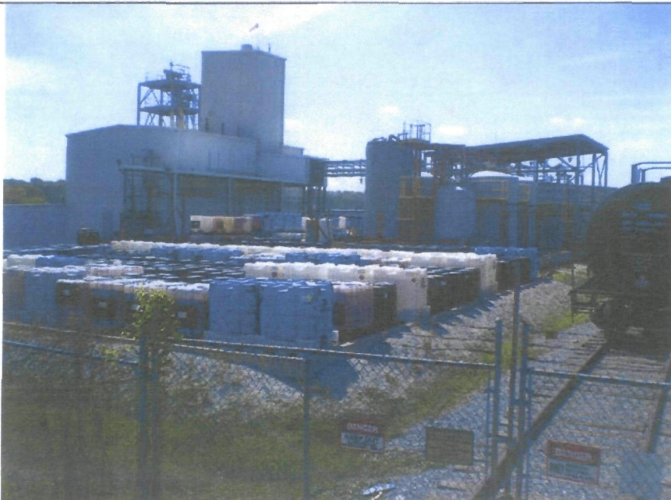
<b>Photographer:</b>	Les Branscum, ADEQ				<b>Witness:</b>	Penny Wilson, ADEQ	
<b>Photo #</b>	2	<b>Of</b>	10		<b>Date:</b>	22 AUG 07	<b>Time:</b> 1107
<b>Description:</b>	View of Diaz facility from NW corner on rail spur. Rail car is placarded Flammable Liquid, UN2387 and labeled Fluorobenzene.

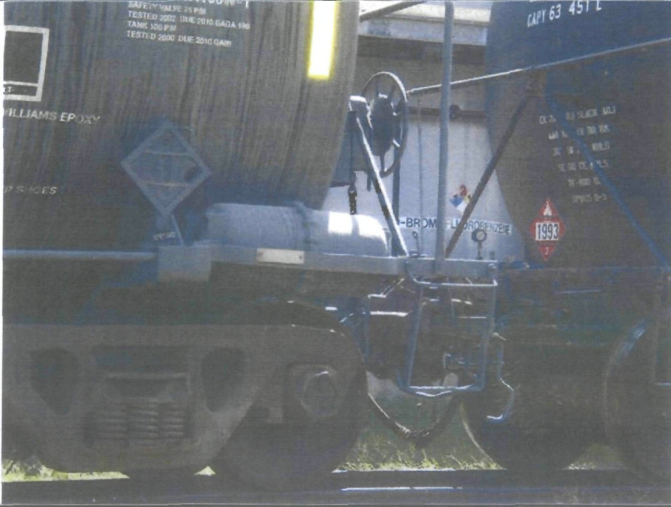
<b>Location:</b>	Diaz Intermediates Corp., 301 Wyanoke Rd., West Memphis, AR 72301						
<b>Photographer:</b>	Les Branscum, ADEQ				<b>Witness:</b>	Penny Wilson, ADEQ	
<b>Photo #</b>	3	<b>Of</b>	10		<b>Date:</b>	22 AUG 07	<b>Time:</b> 1122
<b>Description:</b>	View of P-Bromofluorobenzene tank through the fence on the west side of the Diaz facility.

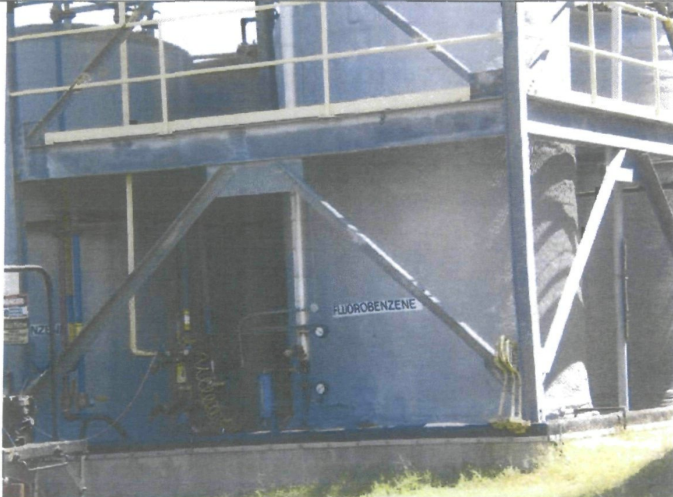
<b>Photographer:</b>	Les Branscum, ADEQ				<b>Witness:</b>	Penny Wilson, ADEQ	
<b>Photo #</b>	4	<b>Of</b>	10		<b>Date:</b>	22 AUG 07	<b>Time:</b> 1123
<b>Description:</b>	Fluorobenzene tank as viewed through the fence on the west side of the facility, (tank in above photo is to the left). Both photos are facing east.

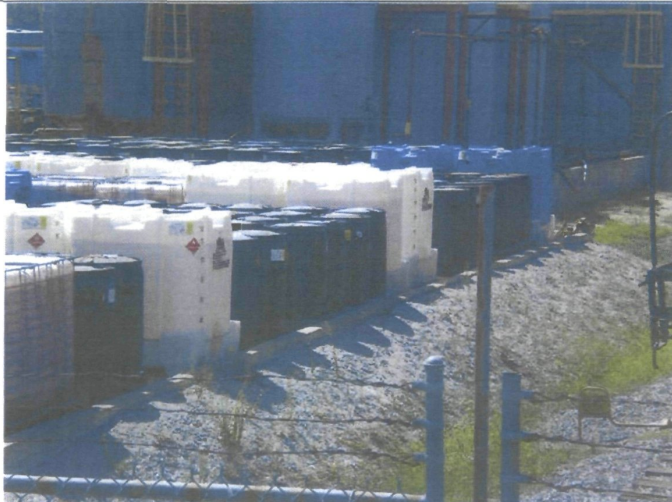
<b>Location:</b>		Diaz Intermediates Corp., 301 Wyanoke Rd., West Memphis, AR 72301						
<b>Photographer:</b>		Les Branscum, ADEQ			<b>Witness:</b>		Penny Wilson, ADEQ	
<b>Photo #</b>	5	<b>Of</b>	10		<b>Date:</b>	22 AUG 07	<b>Time:</b>	1108
<b>Description:</b>		View of west side of drum storage pad at north end of property, facing south.

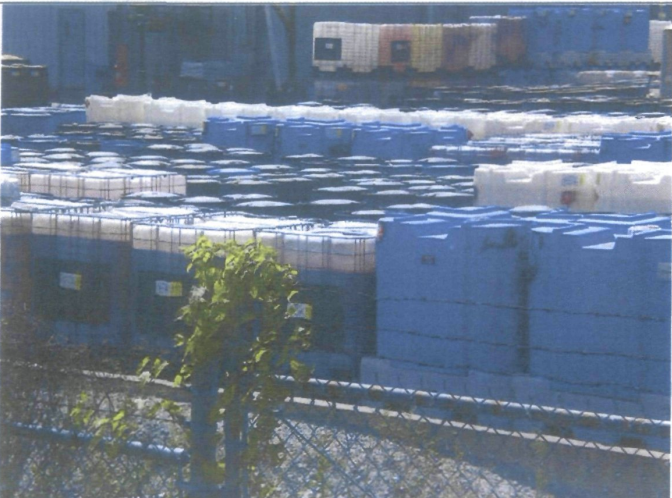
<b>Photographer:</b>		Les Branscum, ADEQ			<b>Witness:</b>		Penny Wilson, ADEQ	
<b>Photo #</b>	6	<b>Of</b>	10		<b>Date:</b>	22 AUG 07	<b>Time:</b>	1108
<b>Description:</b>		View to left of above photo looking into the facility.

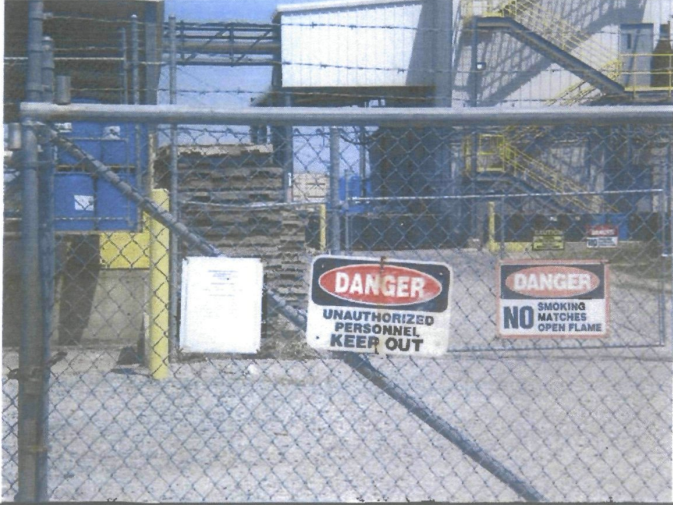
<b>Location:</b>		Diaz Intermediates Corp., 301 Wyanoke Rd., West Memphis, AR 72301						
<b>Photographer:</b>		Les Branscum, ADEQ			<b>Witness:</b>		Penny Wilson, ADEQ	
<b>Photo #</b>	7	<b>Of</b>	10		<b>Date:</b>	22 AUG 07	<b>Time:</b>	1145
<b>Description:</b>		Photo of front gate showing warning signs and secondary entrance in background, facing north.

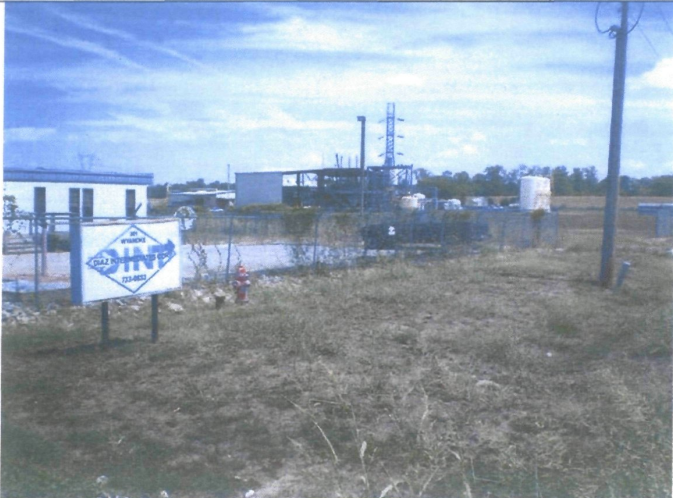
<b>Photographer:</b>		Les Branscum, ADEQ			<b>Witness:</b>		Penny Wilson, ADEQ	
<b>Photo #</b>	8	<b>Of</b>	10		<b>Date:</b>	22 AUG 07	<b>Time:</b>	1146
<b>Description:</b>		Diaz facility sign with the Tetra facility in the background to the east.

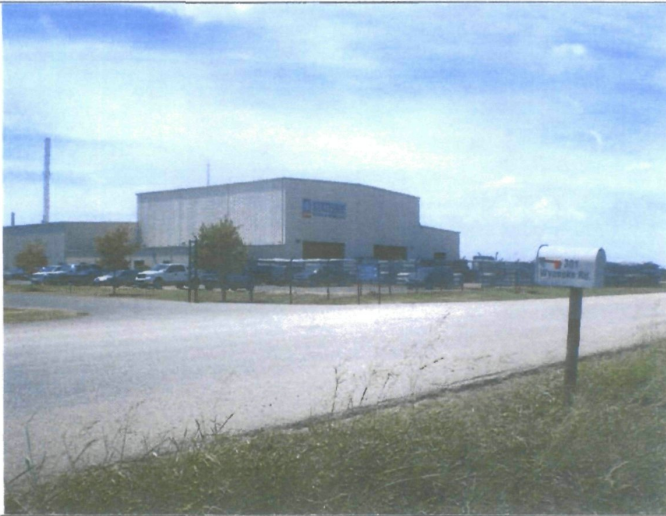
<b>Location:</b>		Diaz Intermediates Corp., 301 Wyanoke Rd., West Memphis, AR 72301					
<b>Photographer:</b>		Les Branscum, ADEQ			<b>Witness:</b>		Penny Wilson, ADEQ
<b>Photo #</b>	9	<b>Of</b>	10		<b>Date:</b>	22 AUG 07	<b>Time:</b> 1146
<b>Description:</b>		View from front of Diaz property showing Diaz mail box and Stateside Steel & Wire to the south.

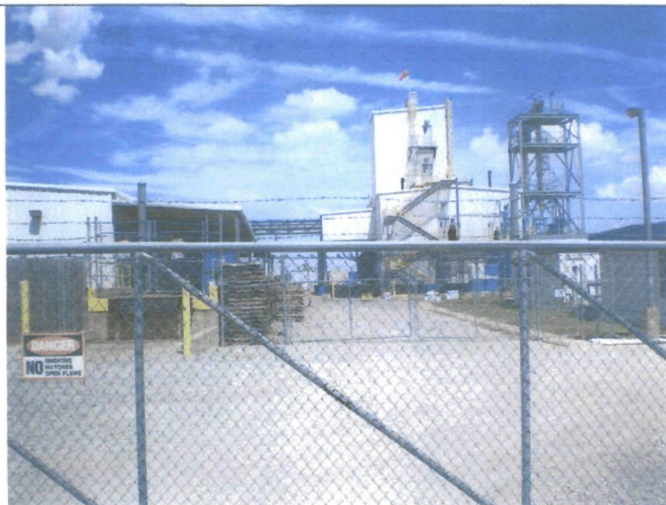
<b>Photographer:</b>		Les Branscum, ADEQ			<b>Witness:</b>		Penny Wilson, ADEQ
<b>Photo #</b>	10	<b>Of</b>	10		<b>Date:</b>	22 AUG 07	<b>Time:</b> 1148
<b>Description:</b>		View from street into Diaz facility showing the Production building in background and warehouse to the left.

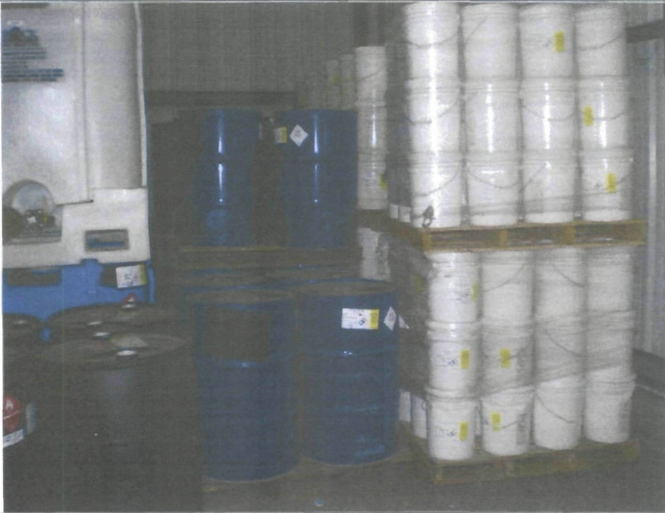
<b>Location:</b>		Diaz Intermediates Corp., 301 Wyanoke Rd., West Memphis, AR 72301					
<b>Photographer:</b>		Les Branscum, ADEQ			<b>Witness:</b>		Penny Wilson, ADEQ
<b>Photo #</b>	1	<b>Of</b>	67		<b>Date:</b>	28 AUG 07	<b>Time:</b> 1038
<b>Description:</b>		SW corner of the Diaz warehouse. On the right are 5 gal pails of P-Dibromobenzene (99%) and the 55 gal blue drums contain 2-Bromopyridine. Photo facing south.

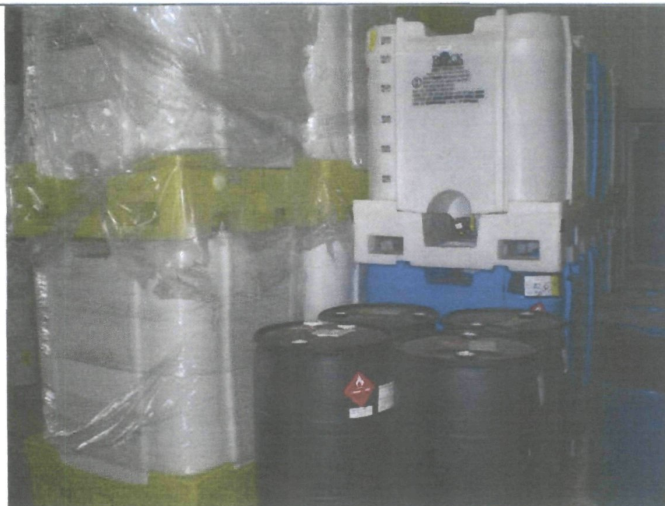
<b>Photographer:</b>		Les Branscum, ADEQ			<b>Witness:</b>		Penny Wilson, (ADEQ)
<b>Photo #</b>	2	<b>Of</b>	67		<b>Date:</b>	28 AUG 07	<b>Time:</b> 1043
<b>Description:</b>		Items to the left of those in photo #1 include black 55 gal drums and 275 gal totes of n-Propanol (fresh). The 300 gallon plastic wrapped totes on the left are empty.

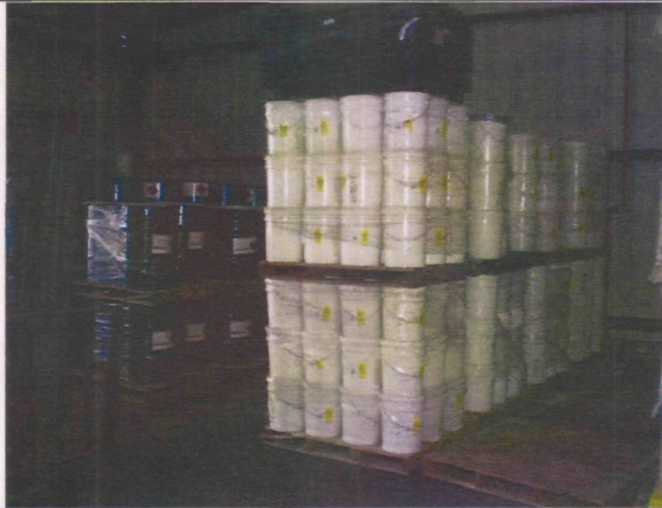
<b>Photographer:</b>	Les Branscum, ADEQ				<b>Witness:</b>	Penny Wilson, ADEQ	
<b>Photo #</b>	4	<b>Of</b>	67		<b>Date:</b>	28 AUG 07	<b>Time:</b> 1050
<b>Description:</b>	Drums to the left of those in photo 3; black 30 gal drums of Aluminum Chloride, Anhydrous and blue 55 gal drums of Methanol.

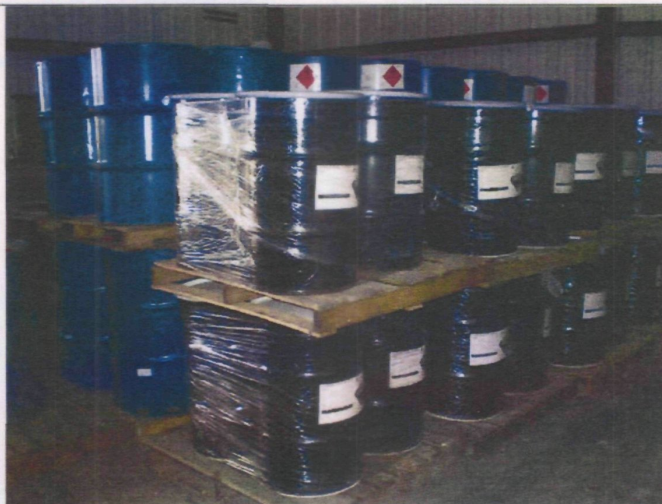
<b>Location:</b>		Diaz Intermediates Corp., 301 Wyanoke Rd., West Memphis, AR 72301							
<b>Photographer:</b>		Les Branscum, ADEQ			<b>Witness:</b>		Penny Wilson, ADEQ		
<b>Photo #</b>	5	<b>Of</b>	67			<b>Date:</b>	28 AUG 07	<b>Time:</b>	1054
<b>Description:</b>		Southeast corner of the Diaz warehouse. Items in foreground are drum pumps with one drum of hazardous waste Benzene behind them. Drums stacked 2 high are Di-Bromobenzene (R).

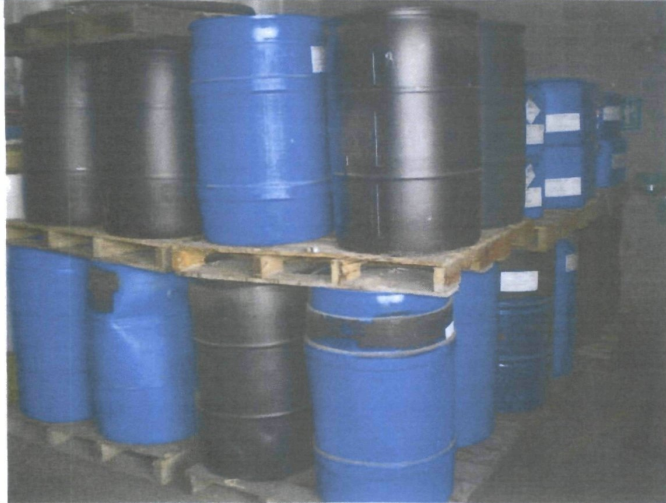
<b>Photographer:</b>		Les Branscum, ADEQ			<b>Witness:</b>		Penny Wilson, ADEQ		
<b>Photo #</b>	6	<b>Of</b>	67			<b>Date:</b>	28 AUG 07	<b>Time:</b>	1059
<b>Description:</b>		North wall, east side of warehouse. Labeled containers at back right are 55 gal drums of M-Fluorobenzaldehyde on the bottom and 2 kilo containers of M-Bromophenol and 2-Bromopyridine on top pallet.

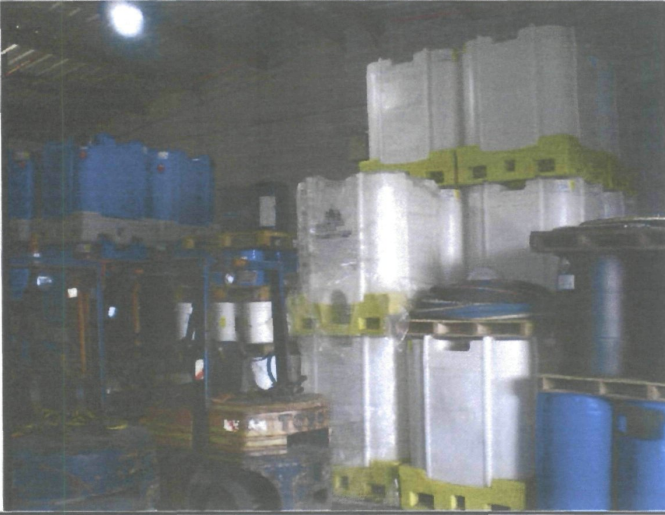
<b>Location:</b>	Diaz Intermediates Corp., 301 Wyanoke Rd., West Memphis, AR 72301						
<b>Photographer:</b>	Les Branscum, ADEQ				<b>Witness:</b>	Penny Wilson, ADEQ	
<b>Photo #</b>	7	<b>Of</b>	67		<b>Date:</b>	28 AUG 07	<b>Time:</b> 1103
<b>Description:</b>	Northwest view of north wall, Diaz warehouse. 300 gal white totes contain M-Bromoanisole (high purity).

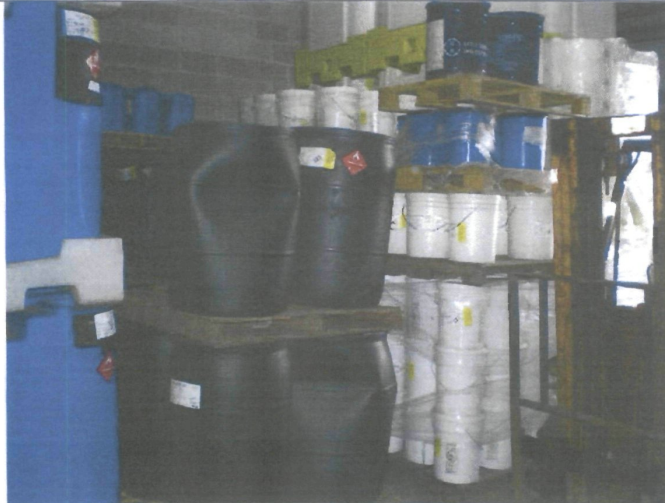
<b>Photographer:</b>	Les Branscum, ADEQ				<b>Witness:</b>	Penny Wilson, ADEQ	
<b>Photo #</b>	8	<b>Of</b>	67		<b>Date:</b>	28 AUG 07	<b>Time:</b> 1106
<b>Description:</b>	North wall of warehouse, opposite side of totes in photo 7. 5 gal white pails contain P-Bromochlorobenzene. Blue pails on top of these are labeled P-Dibromobenzene.

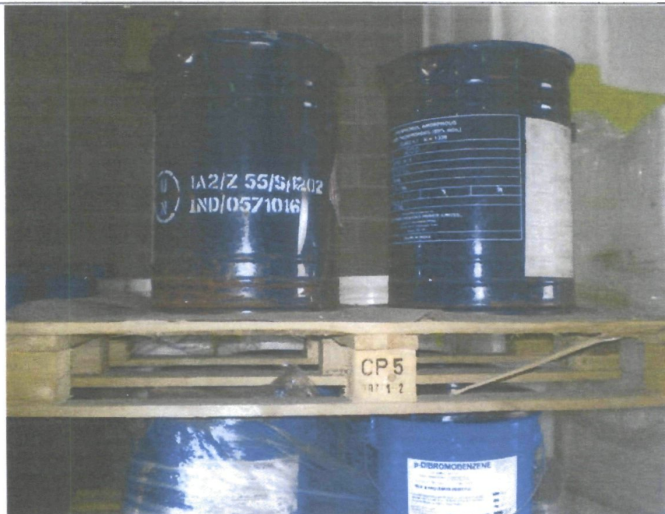
<b>Location:</b>	Diaz Intermediates Corp., 301 Wyanoke Rd., West Memphis, AR 72301						
<b>Photographer:</b>	Les Branscum, ADEQ				<b>Witness:</b>	Penny Wilson, ADEQ	
<b>Photo #</b>	9	<b>Of</b>	67		<b>Date:</b>	28 AUG 07	<b>Time:</b> 1111
<b>Description:</b>	Two 5 gal cans on top of the stack in photo 8. These are labeled 'Phosphorus, Amorphous- Red Phosphorous (99%)'.

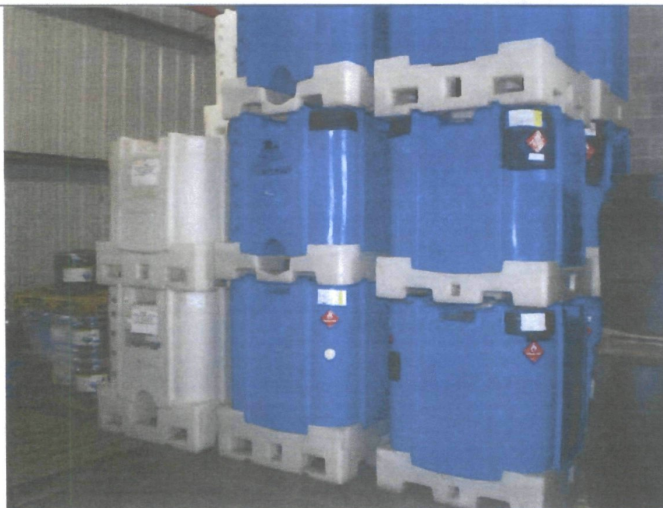
<b>Photographer:</b>	Les Branscum, ADEQ				<b>Witness:</b>	Penny Wilson, ADEQ	
<b>Photo #</b>	10	<b>Of</b>	67		<b>Date:</b>	28 AUG 07	<b>Time:</b> 1114
<b>Description:</b>	Northwest corner of warehouse, 275 gal blue totes labeled N-Propylbromide.

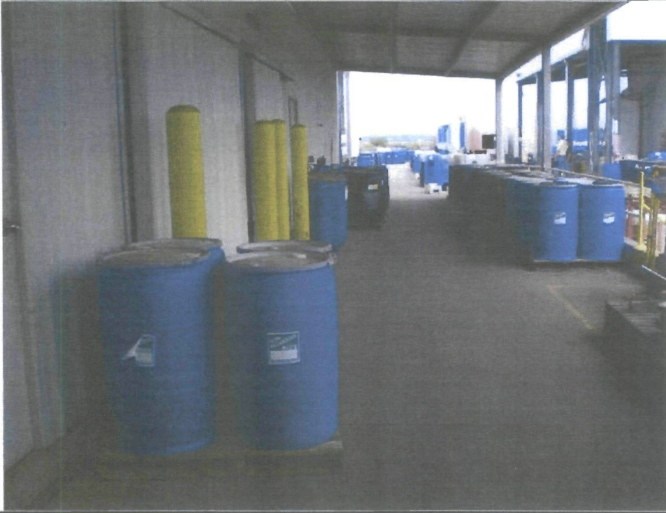
<b>Location:</b>	Diaz Intermediates Corp., 301 Wyanoke Rd., West Memphis, AR 72301							
<b>Photographer:</b>	Les Branscum, ADEQ				<b>Witness:</b>	Penny Wilson, ADEQ		
<b>Photo #</b>	13	<b>Of</b>	67		<b>Date:</b>	28 AUG 07	<b>Time:</b>	1124
<b>Description:</b>	View of loading dock on east side of warehouse facing north. Approx. 12 non hazardous blue drums are on the dock.

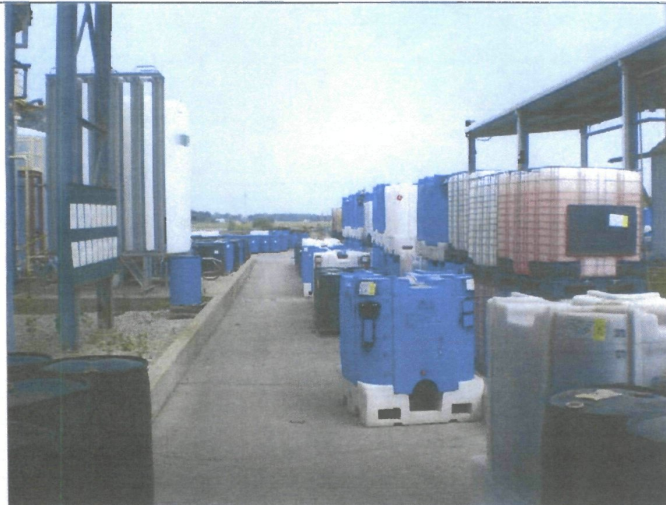
<b>Photographer:</b>	Les Branscum, ADEQ				<b>Witness:</b>	Penny Wilson, ADEQ		
<b>Photo #</b>	14	<b>Of</b>	67		<b>Date:</b>	28 AUG 07	<b>Time:</b>	1127
<b>Description:</b>	Forklift path on north end of loading dock facing north. Above ground tanks in containment are to the left.

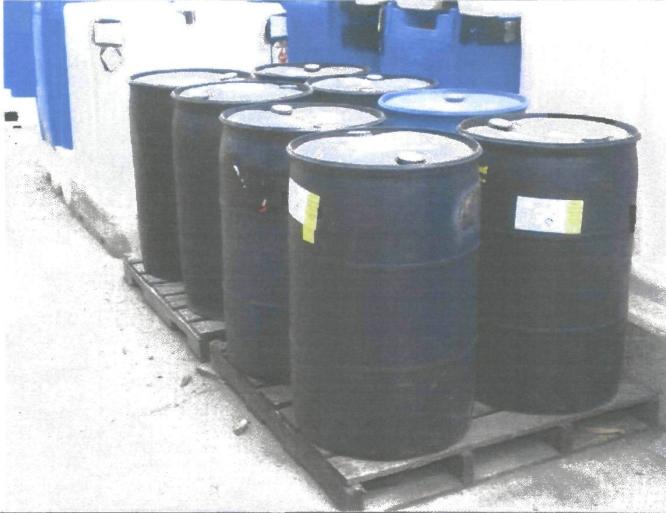
<b>Location:</b>	Diaz Intermediates Corp., 301 Wyanoke Rd., West Memphis, AR 72301							
<b>Photographer:</b>	Les Branscum, ADEQ				<b>Witness:</b>	Penny Wilson, ADEQ		
<b>Photo #</b>	18	<b>Of</b>	67		<b>Date:</b>	28 AUG 07	<b>Time:</b>	1150
<b>Description:</b>	Facing north on the forklift pad. Eight 55 gal drums labeled 'MBFB65 (WP) (WET PURE)'.

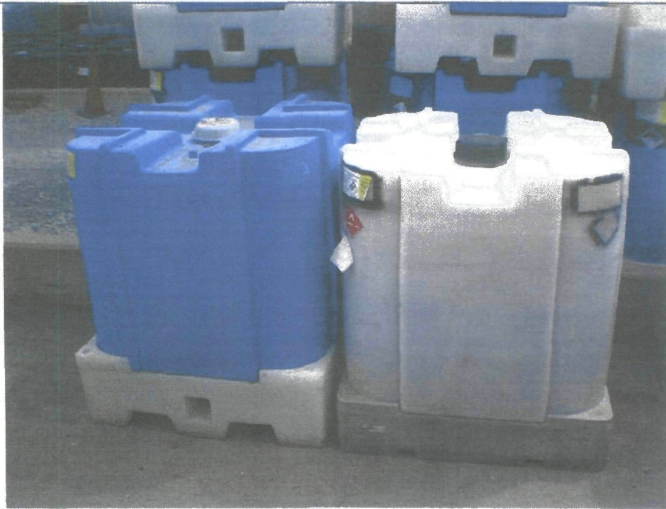
<b>Photographer:</b>	Les Branscum, ADEQ				<b>Witness:</b>	Penny Wilson, ADEQ		
<b>Photo #</b>	19	<b>Of</b>	67		<b>Date:</b>	28 AUG 07	<b>Time:</b>	1153
<b>Description:</b>	275 gal totes to the left of the drums in photo 18 labeled M-Bromofluorobenzene 65%.

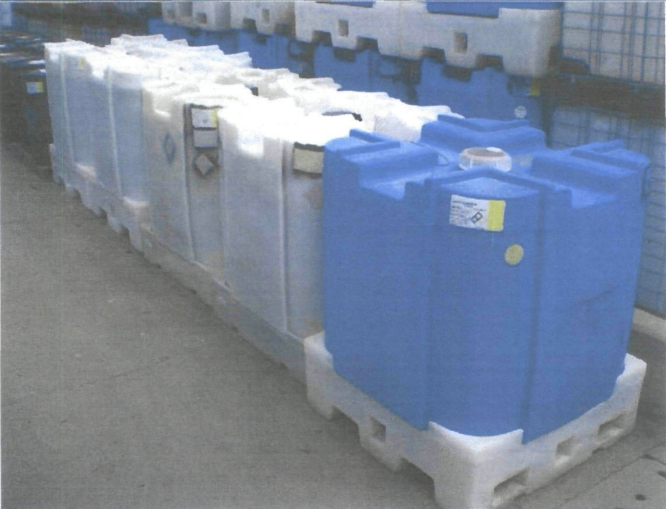
<b>Location:</b>		Diaz Intermediates Corp., 301 Wyanoke Rd., West Memphis, AR 72301						
<b>Photographer:</b>		Les Branscum, ADEQ			<b>Witness:</b>		Penny Wilson, ADEQ	
<b>Photo #</b>	20	<b>Of</b>	67		<b>Date:</b>	28 AUG 07	<b>Time:</b>	1155
<b>Description:</b>		275 gal totes on right side of forklift path, facing NE. The blue tote is labeled M-Bromofluorobenzene; white ones contain pit water (zinc).

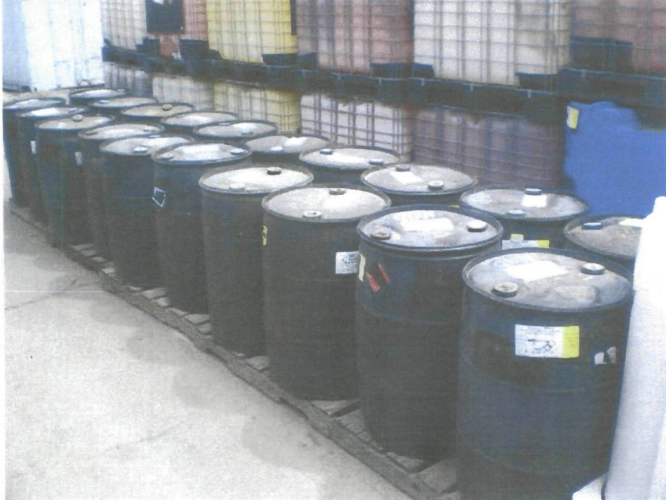
<b>Photographer:</b>		Les Branscum, ADEQ			<b>Witness:</b>		Penny Wilson, ADEQ	
<b>Photo #</b>	21	<b>Of</b>	67		<b>Date:</b>	28 AUG 07	<b>Time:</b>	1157
<b>Description:</b>		Continuing north on the right side of the fork lift path, stand of 55 gal drums. Labels on drums at right read 'DBFB Dibromotoluene Mix'.

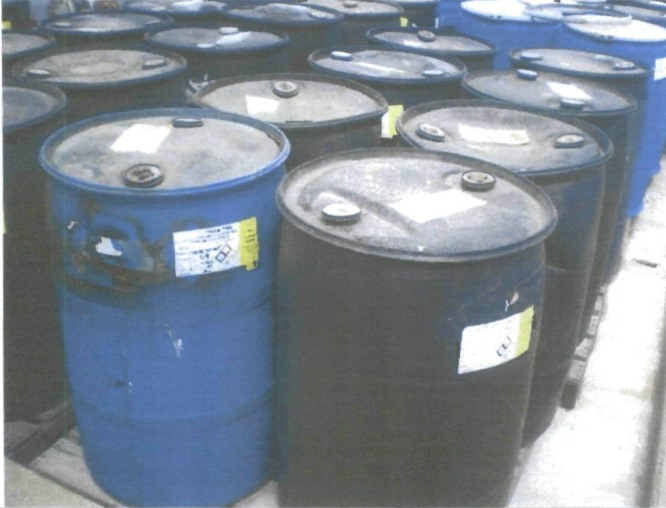
<b>Location:</b>	Diaz Intermediates Corp., 301 Wyanoke Rd., West Memphis, AR 72301						
<b>Photographer:</b>	Les Branscum, ADEQ				<b>Witness:</b>	Penny Wilson, ADEQ	
<b>Photo #</b>	22	<b>Of</b>	67		<b>Date:</b>	28 AUG 07	<b>Time:</b> 1159
<b>Description:</b>	Left side of forklift path facing north. The eight 55 gal drums centered in the photo are all labeled 'DBFB, Dibromotoluene Mix'.

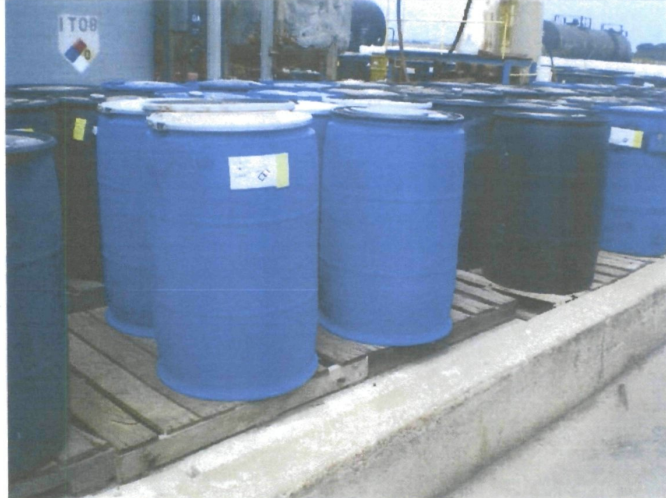
<b>Photographer:</b>	Les Branscum, ADEQ				<b>Witness:</b>	Penny Wilson, ADEQ	
<b>Photo #</b>	23	<b>Of</b>	67		<b>Date:</b>	28 AUG 07	<b>Time:</b> 1202
<b>Description:</b>	Drums just north of those in photo 22. Blue drum to the left is labeled 'MBFB Waste pads/filters'. New and old tank farms are to the left of the photo.

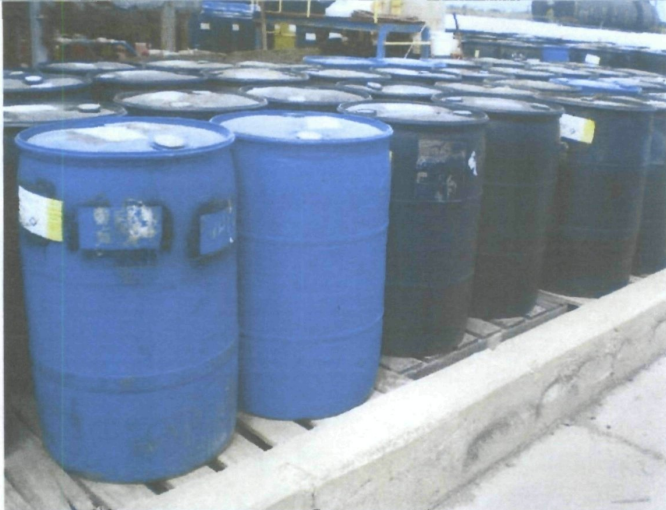
<b>Location:</b>	Diaz Intermediates Corp., 301 Wyanoke Rd., West Memphis, AR 72301						
<b>Photographer:</b>	Les Branscum, ADEQ				<b>Witness:</b>	Penny Wilson, ADEQ	
<b>Photo #</b>	24	<b>Of</b>	67		<b>Date:</b>	28 AUG 07	<b>Time:</b> 1204
<b>Description:</b>	Drums on pad east of 'tank farm', facing NW. Drum on left is labeled 'Mixed Organics (R) Overhead'.

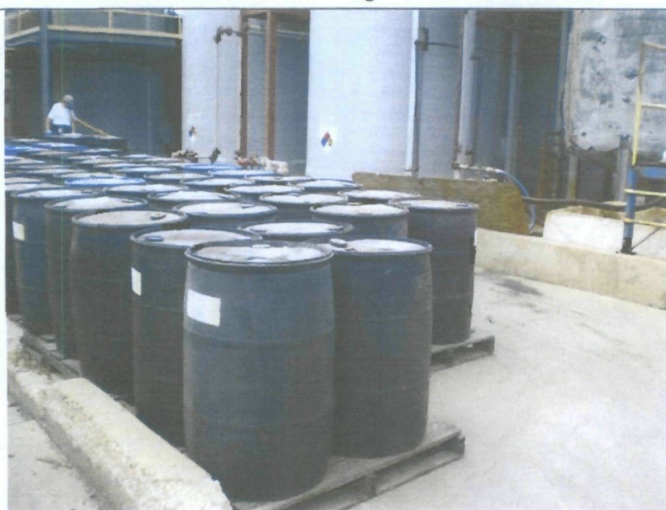
<b>Photographer:</b>	Les Branscum, ADEQ				<b>Witness:</b>	Penny Wilson, ADEQ	
<b>Photo #</b>	25	<b>Of</b>	67		<b>Date:</b>	28 AUG 07	<b>Time:</b> 1212
<b>Description:</b>	Opposite view of drums in photo 24, facing SW with tank farm in background. Last 4 drums on the end of the left row and 2 rows to the right are labeled X-Bromotoluene (T) Bottoms.

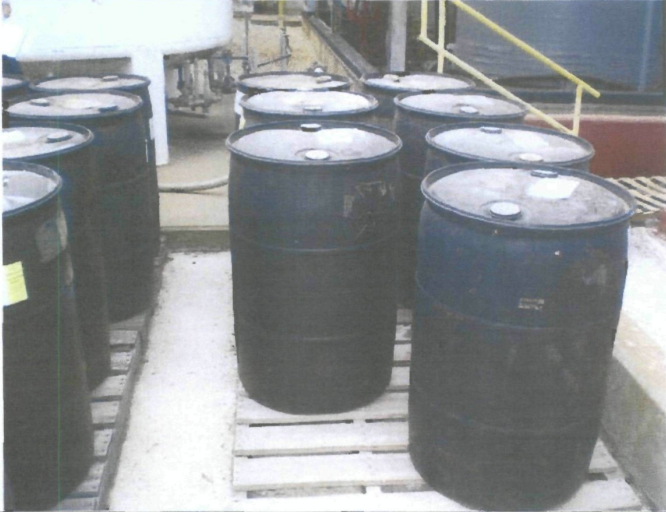
<b>Location:</b>	Diaz Intermediates Corp., 301 Wyanoke Rd., West Memphis, AR 72301						
<b>Photographer:</b>	Les Branscum, ADEQ				<b>Witness:</b>	Penny Wilson, ADEQ	
<b>Photo #</b>	26	<b>Of</b>	67		<b>Date:</b>	28 AUG 07	<b>Time:</b> 1215
<b>Description:</b>	Drums of X-Bromotoluene (C) Crude on opposite end of drums in photo 25, facing south.

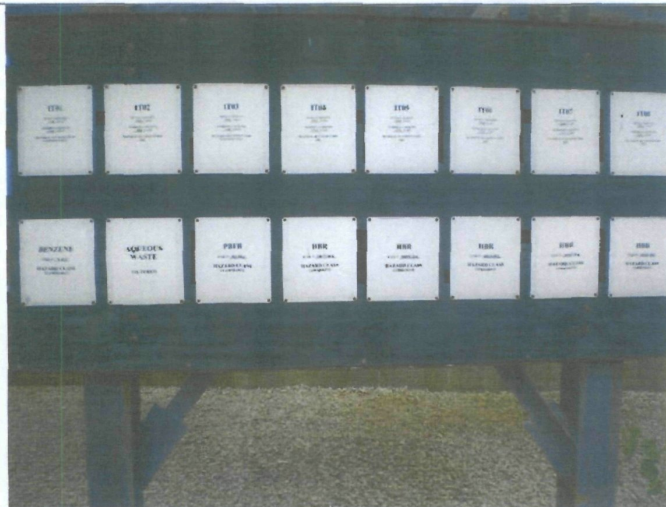
<b>Photographer:</b>	Les Branscum, ADEQ				<b>Witness:</b>	Penny Wilson, ADEQ	
<b>Photo #</b>	27	<b>Of</b>	67		<b>Date:</b>	28 AUG 07	<b>Time:</b> 1319
<b>Description:</b>	Explanation board in front of the old and new 'tank farms', facing west.

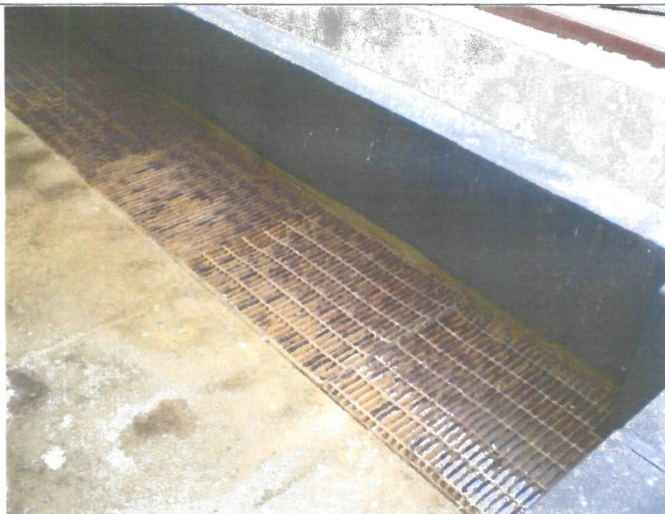
<b>Photographer:</b>	Les Branscum, ADEQ				<b>Witness:</b>	Penny Wilson, ADEQ	
<b>Photo #</b>	29	<b>Of</b>	67		<b>Date:</b>	28 AUG 07	<b>Time:</b> 1331
<b>Description:</b>	New tank farm containment area with standing water. The Spilfyter test strip indicated the Ph for this water between 9 and 10.

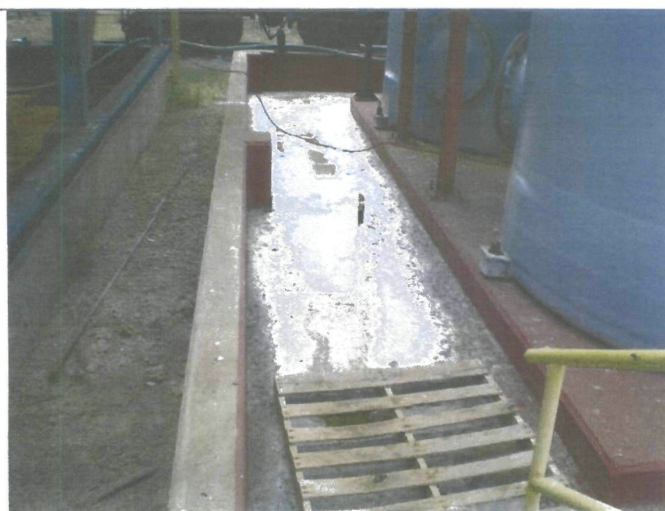
There is an accumulation of some type of liquid with a crystal-like substance on top on the southern end of the secondary containment for this tank farm. The pH of the liquid was between 9 and 10.

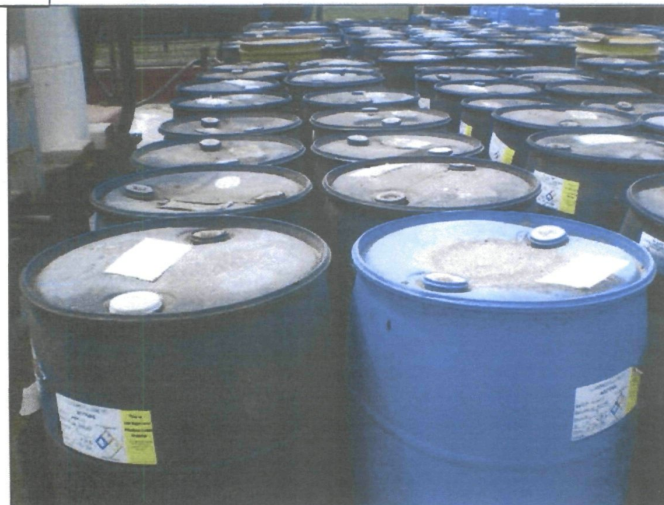
<b>Location:</b>	Diaz Intermediates Corp., 301 Wyanoke Rd., West Memphis, AR 72301						
<b>Photographer:</b>	Les Branscum, ADEQ				<b>Witness:</b>	Penny Wilson, ADEQ	
<b>Photo #</b>	32	<b>Of</b>	67		<b>Date:</b>	28 AUG 07	<b>Time:</b> 1348
<b>Description:</b>	Next 2 rows (row 3&4) of drums on drum pad north of the tank farm, facing west. Drum in left foreground is labeled Dibromotoluene.

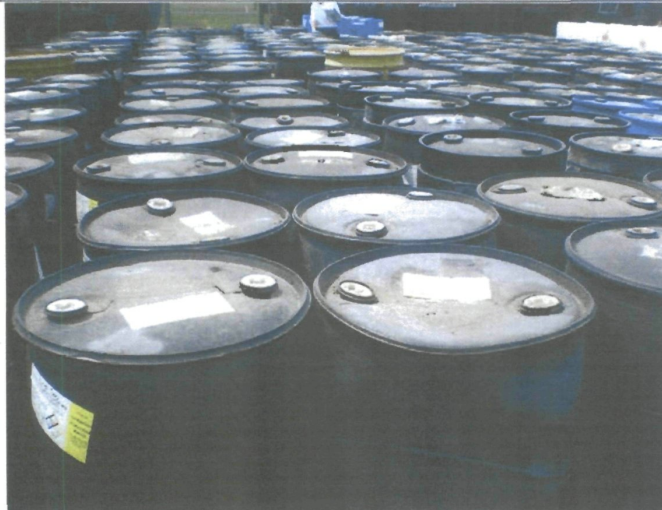
<b>Photographer:</b>	Les Branscum, ADEQ				<b>Witness:</b>	Penny Wilson, ADEQ	
<b>Photo #</b>	33	<b>Of</b>	67		<b>Date:</b>	28 AUG 07	<b>Time:</b> 1352
<b>Description:</b>	Rows 5&6 on the drum pad, facing west.

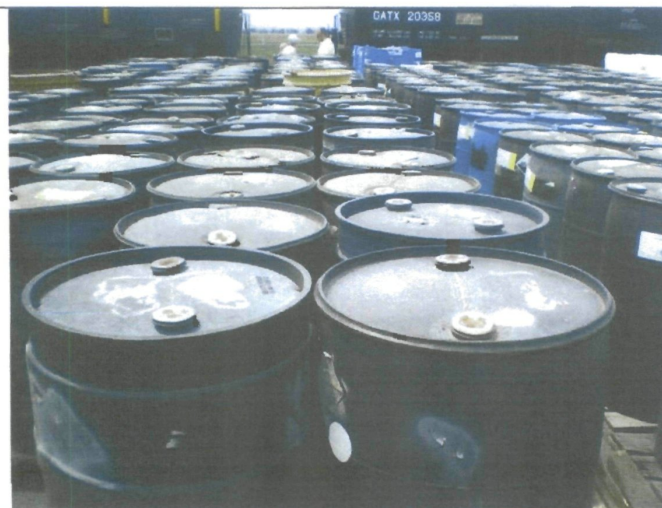
<b>Location:</b>	Diaz Intermediates Corp., 301 Wyanoke Rd., West Memphis, AR 72301							
<b>Photographer:</b>	Les Branscum, ADEQ				<b>Witness:</b>	Penny Wilson, ADEQ		
<b>Photo #</b>	34	<b>Of</b>	67		<b>Date:</b>	28 AUG 07	<b>Time:</b>	1354
<b>Description:</b>	View of rows 5&6 from opposite end showing blue drum on right has a bulging top. Drum is labeled 'M-Dibromobenzene'. Photo facing east.

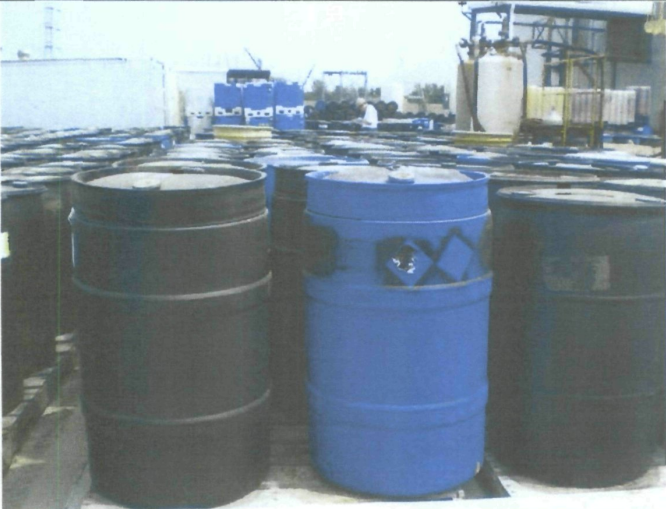
<b>Photographer:</b>	Les Branscum, ADEQ				<b>Witness:</b>	Penny Wilson, ADEQ		
<b>Photo #</b>	35	<b>Of</b>	67		<b>Date:</b>	28 AUG 07	<b>Time:</b>	1358
<b>Description:</b>	Poly drum (3 <sup>rd</sup> from end in above photo of row 6) not leaking but crushed in, no label visible. Photo facing east.

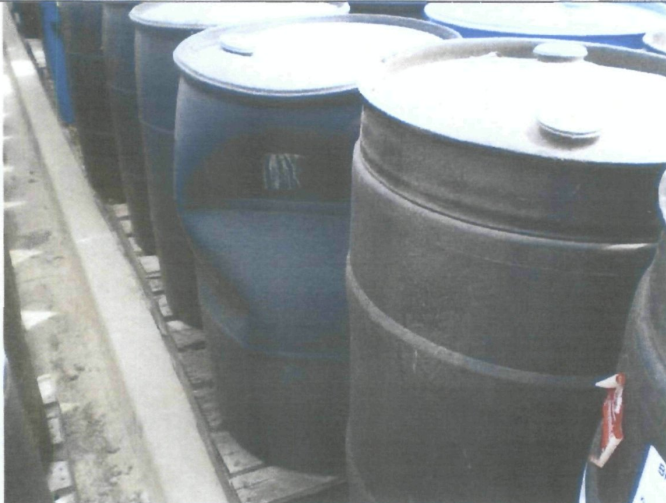
<b>Location:</b>	Diaz Intermediates Corp., 301 Wyanoke Rd., West Memphis, AR 72301							
<b>Photographer:</b>	Les Branscum, ADEQ				<b>Witness:</b>	Penny Wilson, ADEQ		
<b>Photo #</b>	36	<b>Of</b>	67		<b>Date:</b>	28 AUG 07	<b>Time:</b>	1402
<b>Description:</b>	Rows 7&8 on drum pad, facing west. Rail car in background is labeled 'Fluorobenzene' UN 2387, Flammable Liquid.

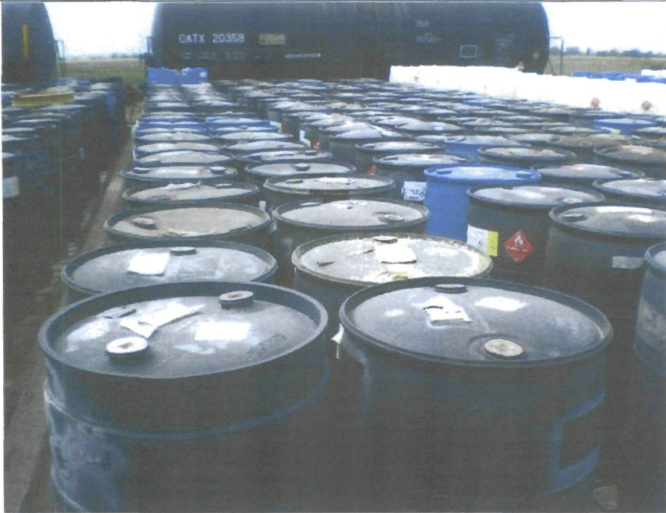
<b>Photographer:</b>	Les Branscum, ADEQ				<b>Witness:</b>	Penny Wilson, ADEQ		
<b>Photo #</b>	37	<b>Of</b>	67		<b>Date:</b>	28 AUG 07	<b>Time:</b>	1403
<b>Description:</b>	Residue on top of 2 <sup>nd</sup> drum in row 8, photo 36. Drum is labeled 'Bromobenzene recycle'.

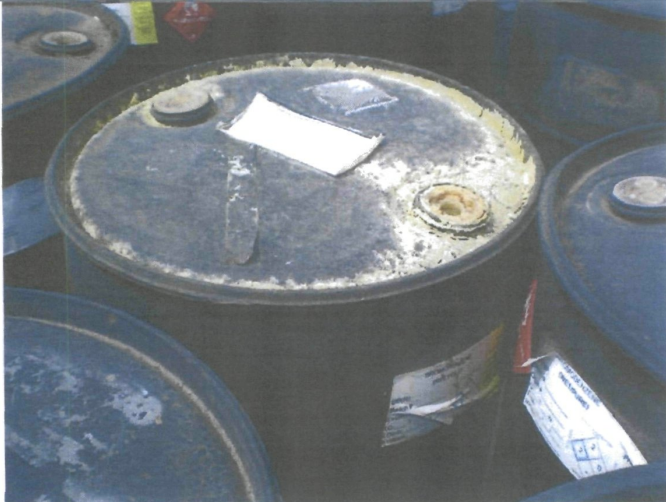
<b>Location:</b>	Diaz Intermediates Corp., 301 Wyanoke Rd., West Memphis, AR 72301							
<b>Photographer:</b>	Les Branscum, ADEQ				<b>Witness:</b>	Penny Wilson, ADEQ		
<b>Photo #</b>	38	<b>Of</b>	67		<b>Date:</b>	28 AUG 07	<b>Time:</b>	1405
<b>Description:</b>	Rows 9&10 on drum pad, facing west. Labels on first two drums indicate they contain '--Propyl Bromide (Tech)'.

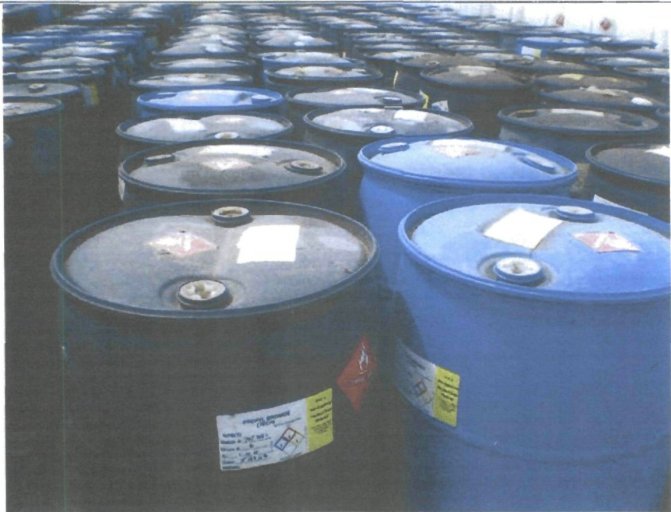
<b>Photographer:</b>	Les Branscum, ADEQ				<b>Witness:</b>	Penny Wilson, ADEQ		
<b>Photo #</b>	39	<b>Of</b>	67		<b>Date:</b>	28 AUG 07	<b>Time:</b>	1406
<b>Description:</b>	Rows 11&12 on drum pad, facing west. First drum in row 12 is labeled 'HCL/HBR mix SG>1.1'. It is also dated 1-31-06.

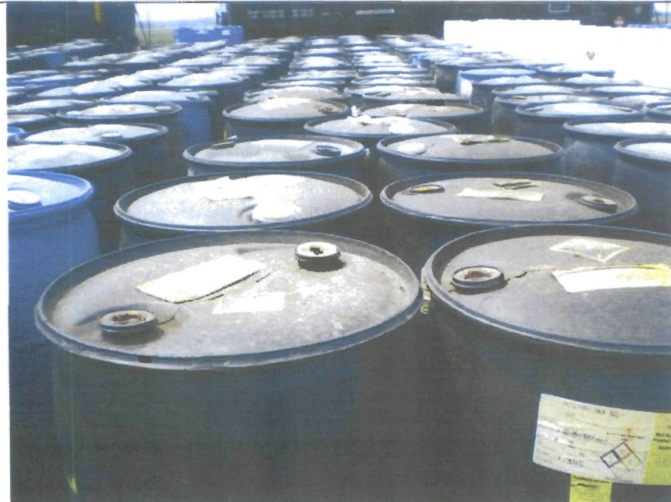
<b>Location:</b>	Diaz Intermediates Corp., 301 Wyanoke Rd., West Memphis, AR 72301							
<b>Photographer:</b>	Les Branscum, ADEQ				<b>Witness:</b>	Penny Wilson, ADEQ		
<b>Photo #</b>	40	<b>Of</b>	67		<b>Date:</b>	28 AUG 07	<b>Time:</b>	1408
<b>Description:</b>	Bulging lid on corrosive labeled drum in row 11. Product label indicates the drum contains 'HCL/HBR mix HG>1.1', DATED 1-21-07.

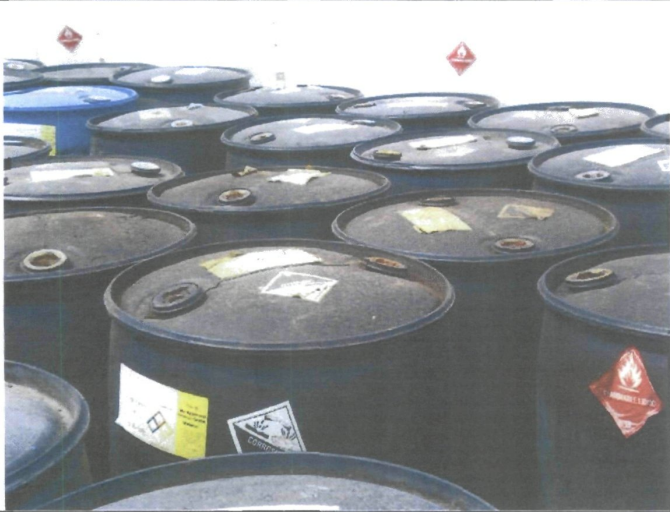
<b>Photographer:</b>	Les Branscum, ADEQ				<b>Witness:</b>	Penny Wilson, ADEQ		
<b>Photo #</b>	41	<b>Of</b>	67		<b>Date:</b>	28 AUG 07	<b>Time:</b>	1409
<b>Description:</b>	Rows 13&14 on drum pad, facing west.

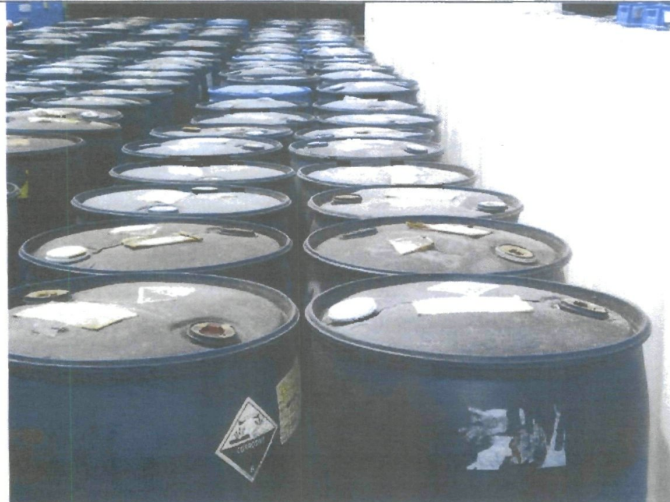
<b>Location:</b>	Diaz Intermediates Corp., 301 Wyanoke Rd., West Memphis, AR 72301							
<b>Photographer:</b>	Les Branscum, ADEQ				<b>Witness:</b>	Penny Wilson, ADEQ		
<b>Photo #</b>	42	<b>Of</b>	67		<b>Date:</b>	28 AUG 07	<b>Time:</b>	1410
<b>Description:</b>	Row 15 on drum pad, facing west. Totes are labeled 'Methanol'.

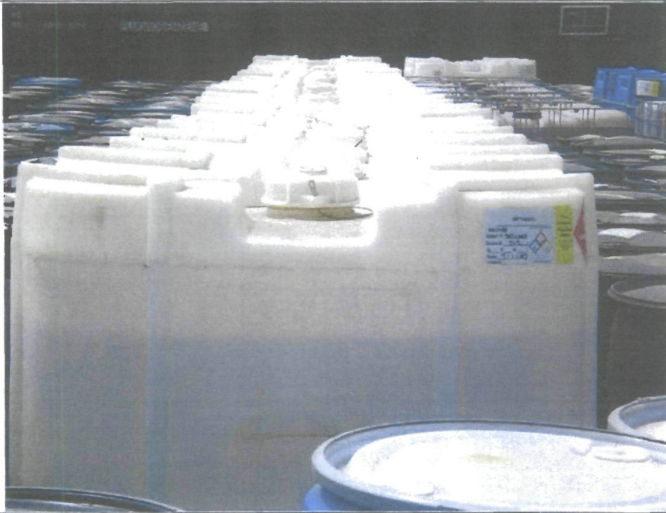
<b>Photographer:</b>	Les Branscum, ADEQ				<b>Witness:</b>	Penny Wilson, ADEQ		
<b>Photo #</b>	43	<b>Of</b>	67		<b>Date:</b>	28 AUG 07	<b>Time:</b>	1412
<b>Description:</b>	Row 16 facing west, drum in front is labeled 'MBFB(H) Nondistilled Water'

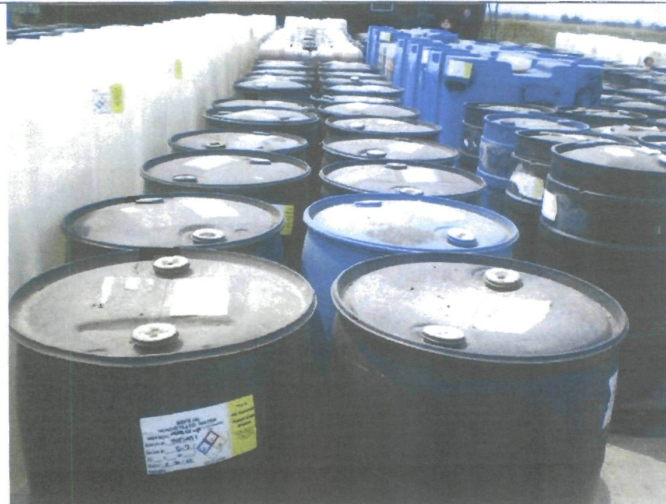
<b>Location:</b>	Diaz Intermediates Corp., 301 Wyanoke Rd., West Memphis, AR 72301										
<b>Photographer:</b>	Les Branscum, ADEQ					<b>Witness:</b>	Penny Wilson, ADEQ				
<b>Photo #</b>	44	<b>Of</b>	67			<b>Date:</b>	28 AUG 07	<b>Time:</b>	1413		
<b>Description:</b>	Row 17 facing west, majority of row is totes two drums wide.

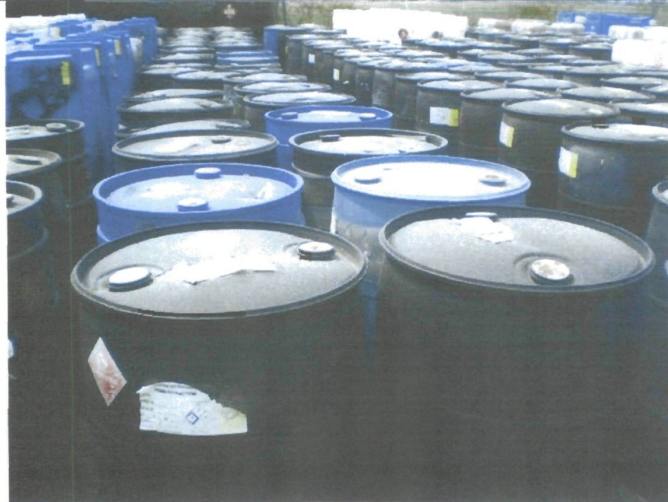
<b>Photographer:</b>	Les Branscum, ADEQ					<b>Witness:</b>	Penny Wilson, ADEQ				
<b>Photo #</b>	45	<b>Of</b>	67			<b>Date:</b>	28 AUG 07	<b>Time:</b>	1416		
<b>Description:</b>	Row 18 facing west, front drum is labeled 'Bromobenzene PDBB-Extraction'.

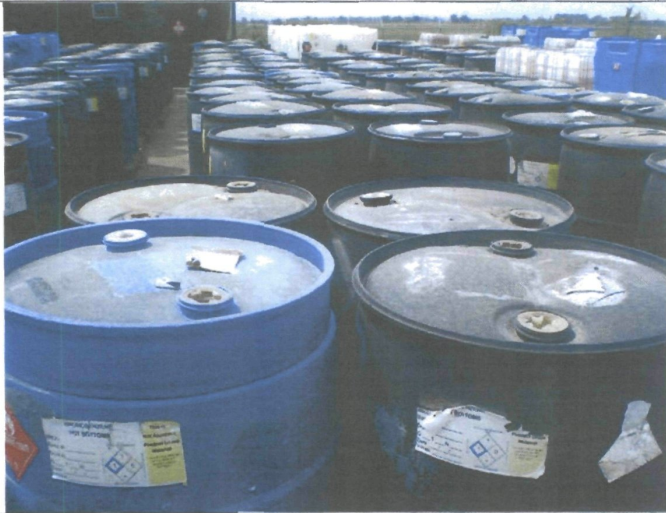
<b>Photographer:</b>		Les Branscum, ADEQ			<b>Witness:</b>		Penny Wilson, ADEQ	
<b>Photo #</b>	47	<b>Of</b>	67		<b>Date:</b>	28 AUG 07	<b>Time:</b>	
<b>Description:</b>		Row 20 facing west on drum pad. Drums in front are labeled 'm-Bromofluorobenzene Recycle'.

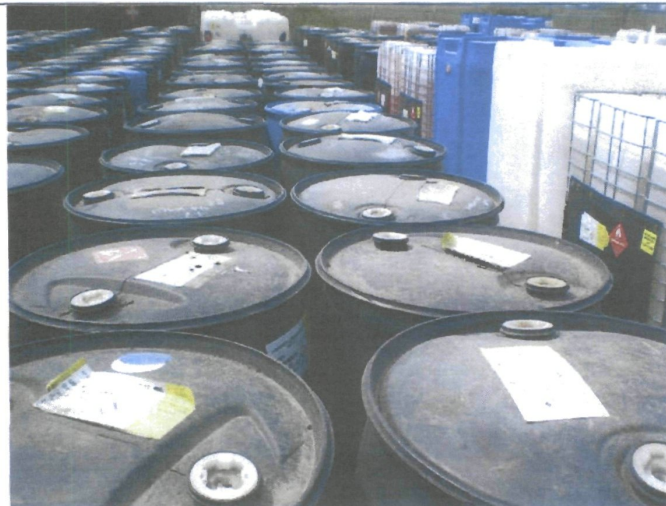
<b>Location:</b>	Diaz Intermediates Corp., 301 Wyanoke Rd., West Memphis, AR 72301							
<b>Photographer:</b>	Les Branscum, ADEQ				<b>Witness:</b>	Penny Wilson, ADEQ		
<b>Photo #</b>	48	<b>Of</b>	67		<b>Date:</b>	28 AUG 07	<b>Time:</b>	1423
<b>Description:</b>	Last rows on drum pad progressing from south to north. Photo is facing NW.

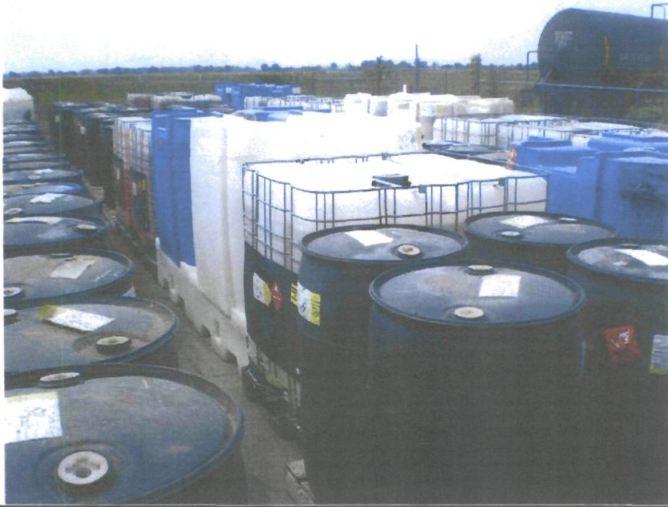
<b>Photographer:</b>	Les Branscum, ADEQ				<b>Witness:</b>	Penny Wilson, ADEQ		
<b>Photo #</b>	49	<b>Of</b>	67		<b>Date:</b>	28 AUG 07	<b>Time:</b>	1425
<b>Description:</b>	Drum in upper left corner of photo 48 that appeared black with a blue lid. Drum is discolored by contents. Label indicates contents are 'Fluorobenzene (Recovered) Acidic' and dated 6-30-07.

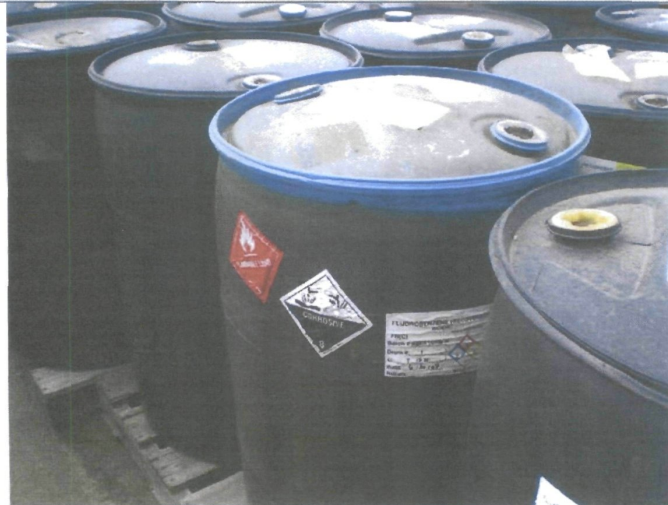
<b>Location:</b>		Diaz Intermediates Corp., 301 Wyanoke Rd., West Memphis, AR 72301						
<b>Photographer:</b>		Les Branscum, ADEQ			<b>Witness:</b>		Penny Wilson, ADEQ	
<b>Photo #</b>	50	<b>Of</b>	67		<b>Date:</b>	28 AUG 07	<b>Time:</b>	1426
<b>Description:</b>		Drums at east end of drum pad, facing north. Drum to right is labeled 'MBFB Nondistilled Water'

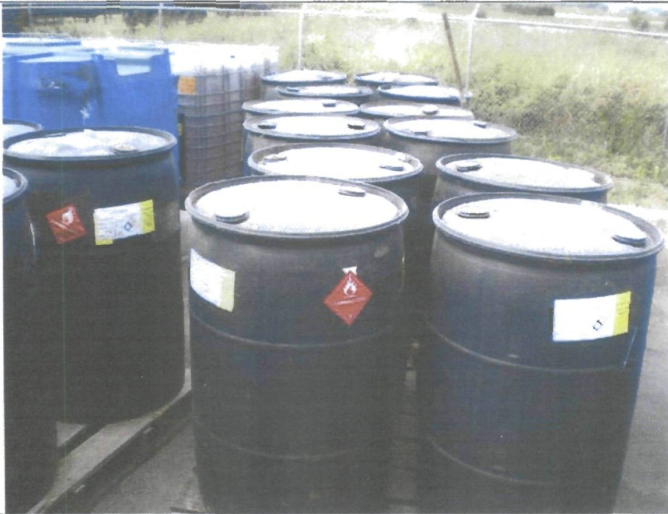
<b>Photographer:</b>		Les Branscum, ADEQ			<b>Witness:</b>		Penny Wilson, ADEQ	
<b>Photo #</b>	51	<b>Of</b>	67		<b>Date:</b>	28 AUG 07	<b>Time:</b>	1431
<b>Description:</b>		Drums on East end of drum pad, (drums in photo 50 are in upper left corner) majority are non-hazardous.
